Utility Structural Systems

November 15, 2005

Scope:

This test was an actual installation of Poly-Ground[®], Utility Structural Systems' newest line of engineered backfills. We believe Poly-Ground[®] has various benefits, such as worker safety and enhanced grounding, but perhaps one of the most significant benefits that can be noted is the lower impedance, which decreases line loss of the system. With this test being conducted on a transmission line, Poly-Ground[®] also provides a safer, faster, and more effective path to ground for electrical discharges of all types and will potentially greatly reduce the incidence of nuisance tripping.

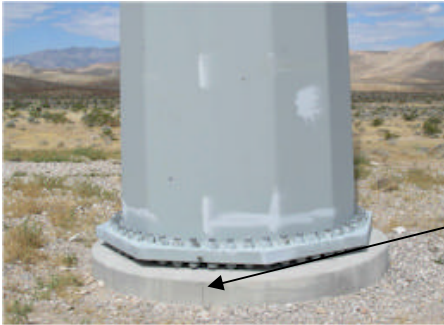
For comparison, we set up to test the structure we identified as the "base pole" which was a pre-cast concrete foundation with the pole bolted to the top of the foundation. The pole was not in direct contact with the soil so, according to construction personnel, it had a 10' x 3/4" ground rod placed in the annular space (although it appeared the ground rod was driven outside the hole given the proximity of the rod to the backfill).

Pole 1: This is a close up view of the initial pole used for base comparison. Note the location of the ground rod at the front base of the structure. Although the rod cannot be identified, the #6 solid copper wire connected to the rod is clearly visible.

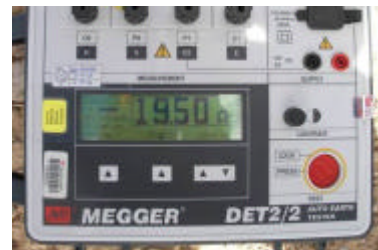
Pole 1: This is a close up view of the actual reading obtained on the above structure. The two red leads are attached to the grounding electrode itself, and the yellow lead is attached to a stake at 62' from the electrode and the blue is attached to a driven stake at 100'. The resistance reading was 19.50 ohms.

This reading was surprisingly lower than expected given the nature of the soil in desert southwest. The soils are generally not considered conductive due to the soil composition and the lack of annual rainfall. The average rainfall in the area is 1/2" per month.

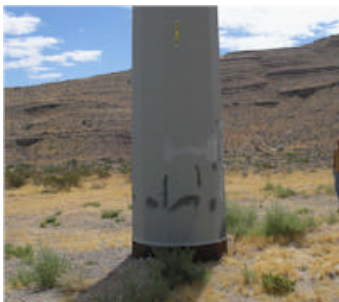
Pole 2: This is a close-up view of the second structure tested. It is a direct embedded pole set in concrete

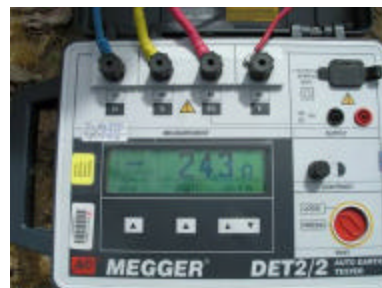
Pole 2: Normal, concrete backfilled pole with 10' x 3/4" copper ground rod. Reading is 24.3 ohms.

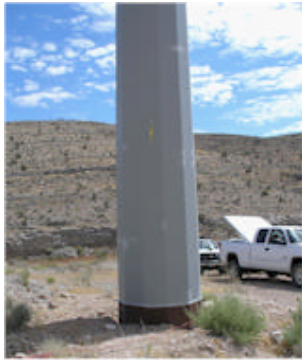
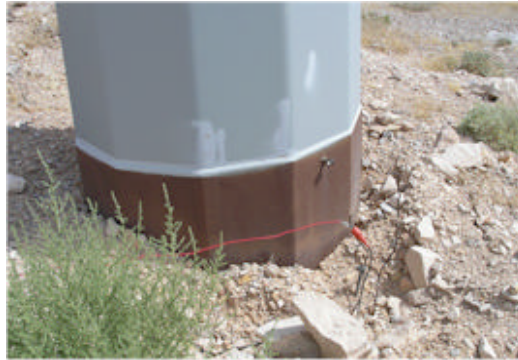
Pole 3: This particular pole had been post-installation retro-fitted with the above described steel plate backfilled with Poly-Ground[®]. It also had a driven rod that was installed during the initial installation.

I was told the reading was not as favorable as they thought it would be, so instead, the ground wire was connected to a ground rod installed during the initial installation. Both of the grounding electrodes in place on this pole were measured isolated and then tied together just to see the effect of combining the two. The readings shown on this structure show a slightly better reading on the ground rod versus the Poly-Ground[®] backfilled plate, but the results were even better when the ground rod and Poly-Ground[®] backfilled plate were tied together (see below).

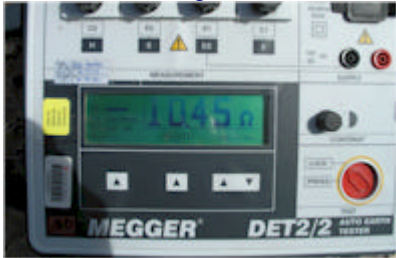
Reading #1

Pole 3: #1 is the ground rod isolated; reading= 10.45 ohms. #2 is the Poly-Ground backfilled plate isolated; reading=13.53 ohms. #3 is the copper rod and Poly-Ground plate tied together; reading= 8.68 ohms.

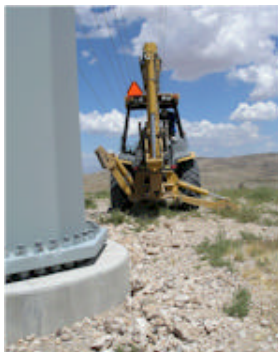
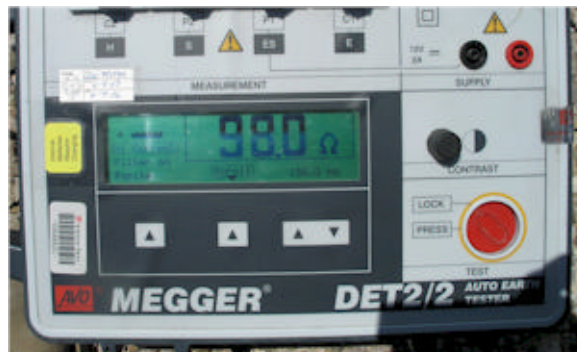
Pole 4: This structure was set on a pre-cast concrete foundation that had a galvanized plate put in the trench but was not treated with any backfill other than native earth. The plate was placed vertically in the trench and backfilled with the excavated material. The reading was 98.0 ohms.

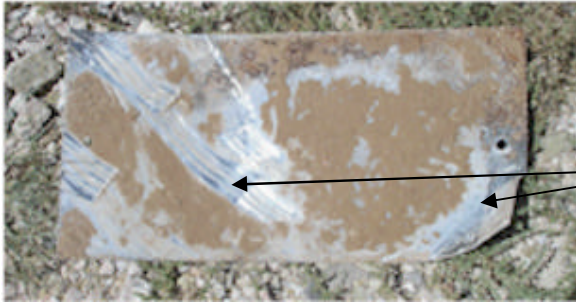
We decided to dig up the plate to check the connection and the condition since it had been in the ground since the July 2004 installation. During the excavation, we confirmed the idea that there was excess moisture located in the subsurface soil. The subsurface soil was very moist in nature and would "clump" together when squeezed. This was completely different than the soil present at the surface. This discovery was slightly disturbing but in all honesty, it was expected. The galvanized plate was dug up using the backhoe (in the above photo) and reviewed for connection and condition. It appeared to have been properly connected using Kearny clips. What was more disturbing was the condition of the plate after 13 months. It would explain the issue currently being discussed throughout the utility industry of the effects of corrosion on steel poles. See photos below:

This is the galvanized plate. The scrape marks are from the backhoe and the excavation process. The hole on the right hand side is where the copper wire was connected. The rust is visible all along the upper and right hand edges.

In this particular case, we decided to re-install a new plate matching the size of the excavated plate and reposition it horizontally and cover with Poly-Ground®. The trench was dug to a depth of about 24" and a width of almost 30". We did not intend to fill the entire trench, but enough Poly-Ground® was placed in the hole to be effective. One Poly-Ground® PG30W kit was poured in the trench and as the foam was expanding the plate was pressed into the foam to insure solid bond and contact with Poly-Ground®.

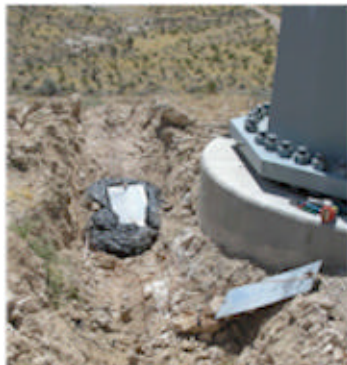
Pole 4: This is a photo showing the trench dug with a Poly-Ground® kit poured in the trench and the galvanized plate placed on top of the risina foam.

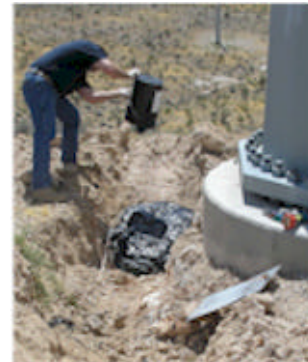
Pole 4: This photo shows a second kit being poured on top of the galvanized plate to insure maximum contact with the plate and to insure a water resistant seal to protect the plate from further degradation.

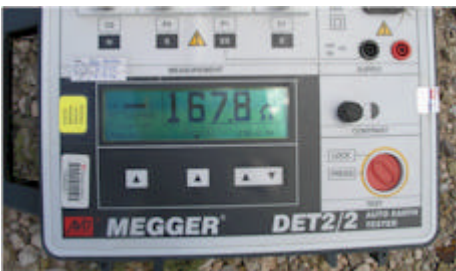
Pole 4: This is the reading of one plate encased in Poly-Ground®. It is important to note the only contact the plate/Poly-Ground® had with the ground was the bottom section as there are no sides and there is no backfill on the top. It is open air. The reading is 167.8 ohms.

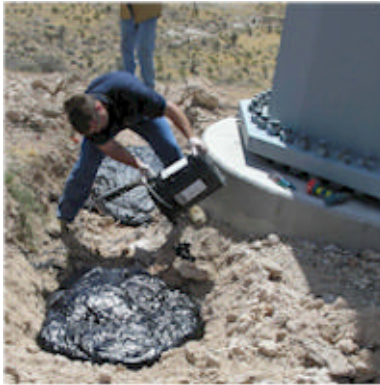
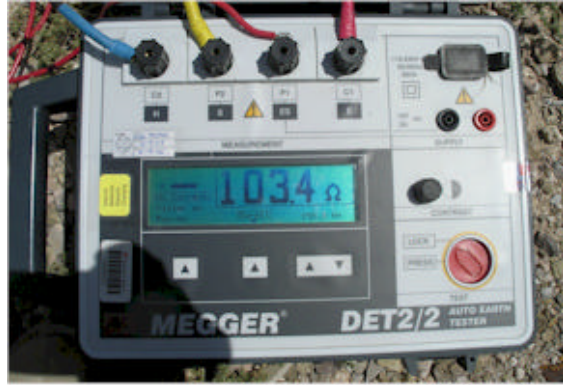
Pole 4: This photo shows the second installation and megger reading was 103.4 ohms. This reading is a cumulative reading of the first plate tied together with the second plate. So there are actually two plates tied together being read here, but there is still only bottom contact being made as the hole is still open air.

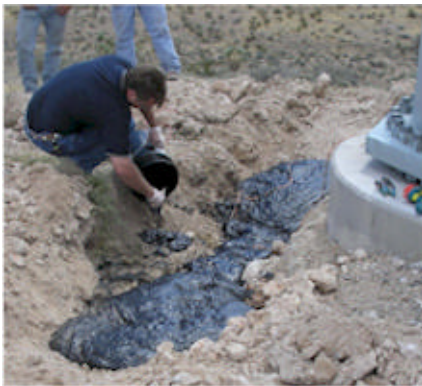
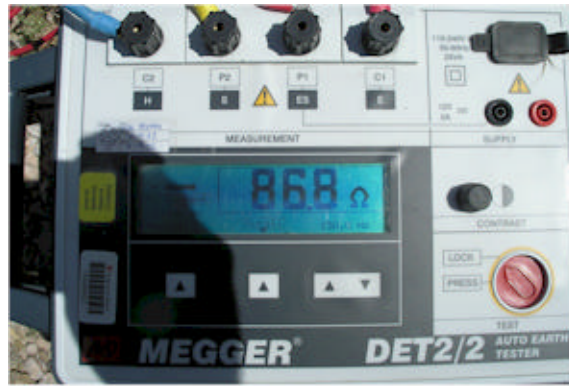
Pole 4: This photo shows the “connecting” of the two plates using a Poly-Ground® only connection and the subsequent reading, keeping in mind there is still only a bottom connection to the earth.

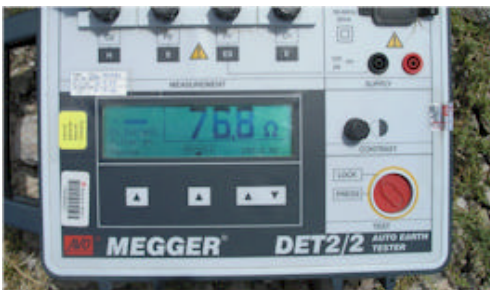
This is a photo showing the final reading of the two installed galvanized plates tied together in a single layer of Poly-Ground® after the trench had been backfilled with soil but not compacted. The final reading was 76.8 ohms.
