Utility Structural Systems

January 26, 2005

This test was an actual installation of Utility Structural Systems newest line of engineered backfills known as Poly-Ground<sup>®</sup>. In our opinion, Poly-Ground<sup>®</sup> has many benefits, such as worker safety and enhanced grounding, but perhaps one of the most significant benefits that can be noted is the lower impedance, which decreases line loss, of the system.

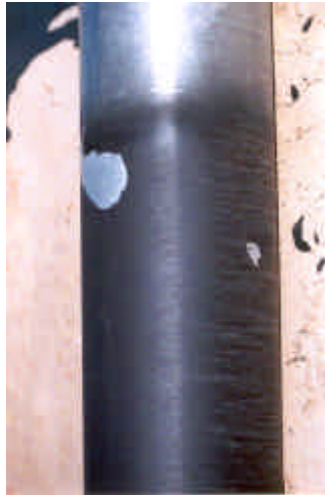
The wood H-Frames were being replaced with newer steel H-Frames identified as H1 class 70' poles. The majority of the embedded portions of these structures were coated with corro-coat but the bottom 2' was left galvanized. Upon examination of these structures, we were able to ascertain there was a problem with the corro-coat. It could not be determined at what point the damage actually occurred. This could have been an adherence problem, or it could just as easily been a pole handling issue. According to the people on site, this was not at all uncommon. What they were looking for was solid data leading to a possible solution of two independent problems they are encountering. The first problem is the resistance on transmission lines in areas where the soil is not beneficial to lowering impedance values. The second was the issue of corrosion on these specific structures throughout the majority of their system. Since Utility Structural Systems has a solution to both of these problems, it was decided the "hybrid foundation" be employed and evaluated. Utility Structural Systems newest product, Poly-Ground<sup>®</sup>, would be installed at the lower depths to cover the uncoated portion of the steel poles so to enhance the grounding thus, lowering the impedance value. The remainder of the void would be filled with Poly-Set<sup>®</sup> to add to the corro-coat, reinforcing any defects and adding several inches of protection. There were also several locations on the poles where large patches of corro-coat were completely missing. One area had about a 3"x18" strip completely missing that did not appear to have adhered at all.

Pole showing Corro-Coat issues
