Utility Structural Systems

This test was an actual installation of Utility Structural Systems newest line of engineered backfills known as Poly-Ground[®]. In our opinion, Poly-Ground[®] has many benefits, such as worker safety and enhanced grounding, but perhaps one of the most significant benefits that can be noted is the lower impedance, which decreases line loss of the system. It also, in this particular case given this was a transmission line, provides a much more effective, safer, and faster path to ground for electrical discharges of all types.

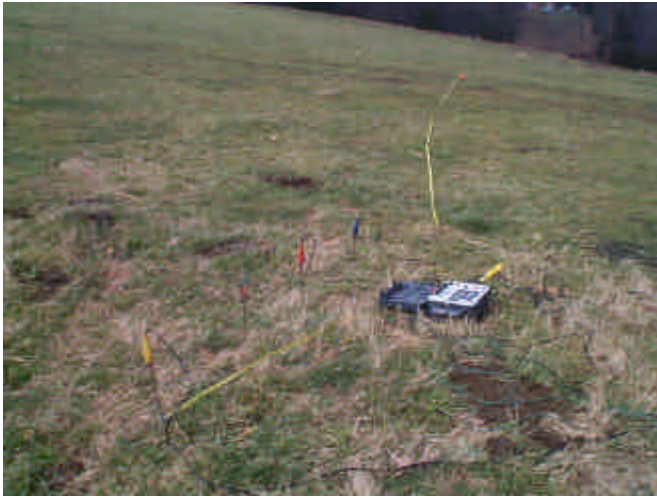
Line Traverse Method for Ground Resistance

Upon arrival I was able to make contact with the crew supervisor responsible for building and constructing the line. It had rained for several days and it rained throughout our entire installation. This particular line was a 161kv H-Frame, wood pole structure that was being refurbished. According to several reports from the crews this line has been installed in the early 1900's. The line was being fed to a substation about 1.5 miles away. The terrain was mainly hills and farmland. I met the crew at another substation to go over the details of the day. We traveled to the East substation and we were able to start talking about what to expect from this project. We traveled to the jobsite and began by doing a soils resistivity test in order to get a baseline reading for the area in which we were working. We used the "line traverse" method for calculating soil resistivity which is an industry standard for this type of testing. We used an AVO International DET 2/2 Digital Earth Tester for this particular test. The need for this type of testing is important due to the fact that you need a baseline of the soil properties to determine the real effectiveness of the Poly-Ground[®] in any given soil condition. The better the soil is, then, theoretically, the less Poly-Ground[®] is needed. Conversely, the worse the soil is, more Poly-Ground[®] is better for the system. Please see the results of the soils reading in the below table. (*Also see Appendix "A" to view a photo of the resistivity method being employed*).

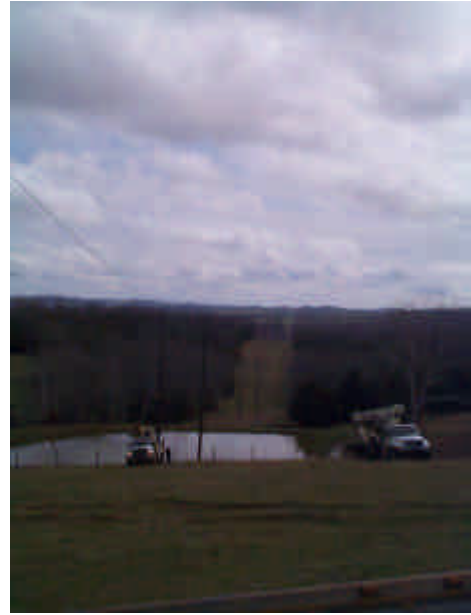
Photo showing existing line

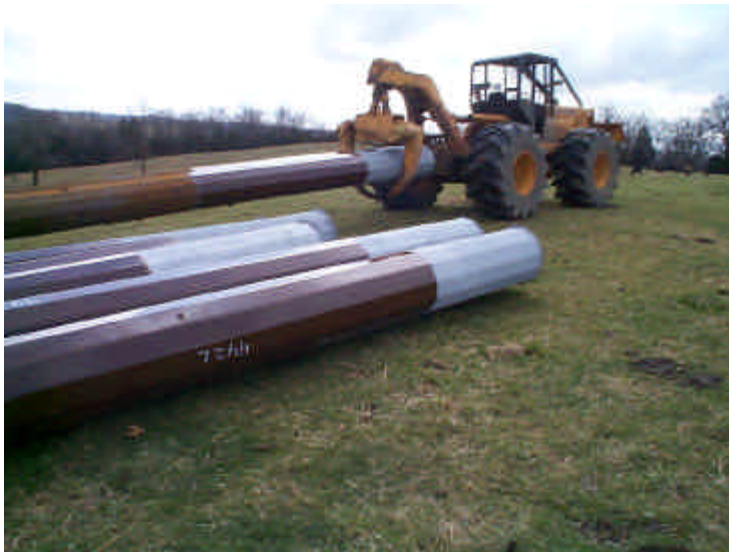
Photo showing poles prior to installation

They were 2-piece Core 10, self-weathering steel poles with corro-coat (or similar product) applied from approximately 3' above grade to 4' above the butt of the pole. The 4' section of the pole was not coated in any way and appeared to have a galvanized finish. (See Appendix "B" for a photo of the poles prior to installation). The pole identification plate listed them as LD3 class poles 65' in height. These poles had a groundline diameter of about 15 1/2" with a butt diameter of 18". The hole was augered out to 26" in diameter to accommodate the new pole being installed. Once in place and plumb, the pole was then backfilled with 2 Poly-Ground[®] kits (PG-30W) and then finished off with a Poly-Set[®] kit (PS-250W). It was suggested by Utility Structural Systems, that the foundation be done this way as Poly-Ground[®] would not make a significant impact on the portion of the pole that was corro-coated because it could not make direct contact with that portion of the pole. We can presume the resistance numbers would have improved, but any improvement would have been negligible. Once set, this structure was not megged but the assumption could be made that the pole would have been relatively identical to the south structure. The south structure was removed in the same fashion and found to be in very close condition to the north structure. The ground wire on this pole was actually in 4 pieces. (Please see Appendix "C" for a photo of the condition of the ground wire). It was this structure that provided a reading of 336 ohms prior to removal, so it was decided that due to weather conditions, we leave the megger probes in place and meg this structure so to save some time in very inclement weather. It would also provide a direct correlation to what the readings were from what was existing to what reading was obtained showing the improvement from the new structure. The structure was backfilled in sections. The first reading obtained was after installing a single Poly-Ground[®] kit. That reading was 3.9 ohms. After the second Poly-Ground[®] kit was installed, a second reading of 4.19 ohms was taken. The reason for the increase is because the Poly-Ground[®] has an exothermic reaction (heat is generated) and heat is resistance. Once the foam cooled down the reading went back down to 3.87 ohms, showing virtually no gain resistance. The remainder of the structure was backfilled with Poly-Set[®]. Cross arms, X-braces and conductor/static installation completed the assembly of the structure and the job was deemed completed. (See Appendix D for the finished structure). I remained on site to answer questions from the crew, and staff. Poly-Ground[®] is similar in installation procedures to Poly-Set[®], however, Poly-Ground[®] MUST be pre-mixed with a drill and the combined foam must also be drill mixed given its much higher viscosity. The installation went well and I again thank all that attended.

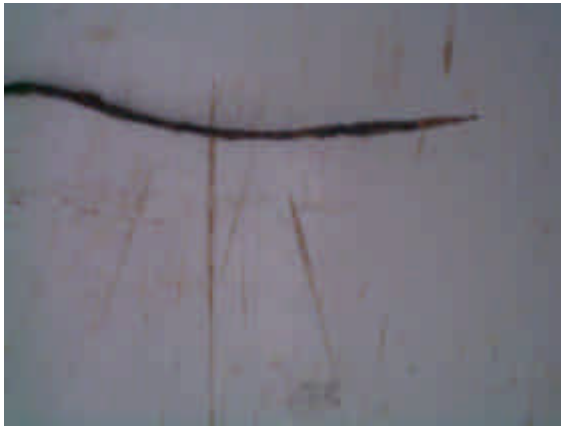
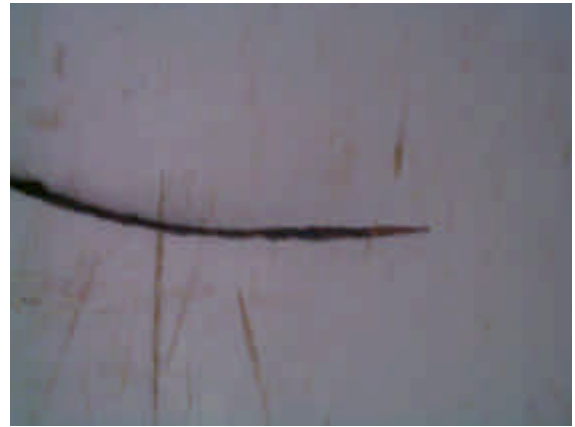
Photos showing the condition of the ground wire that was excavated from the existing structure. The ground wire from the ground line down, was corroded into 4 pieces.

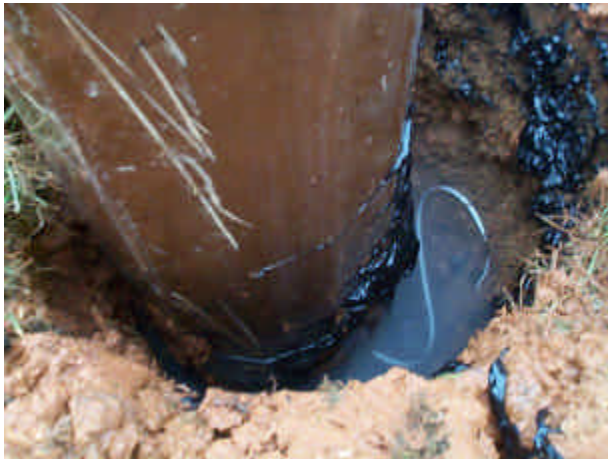
Photo showing Poly-Ground installed prior to Poly-Set backfilling

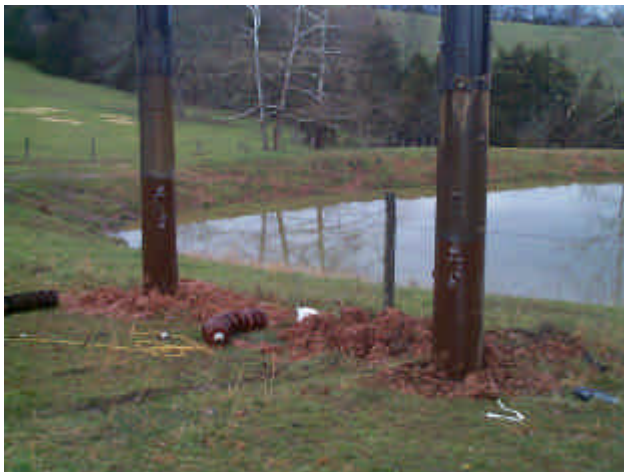
Photo showing finished structure
